## INDOOR UNIT

**No. OBB801**  
**REVISED EDITION-A**

# PARTS CATALOG

**MLZ-KP25VF** - **E1**, **ER1**

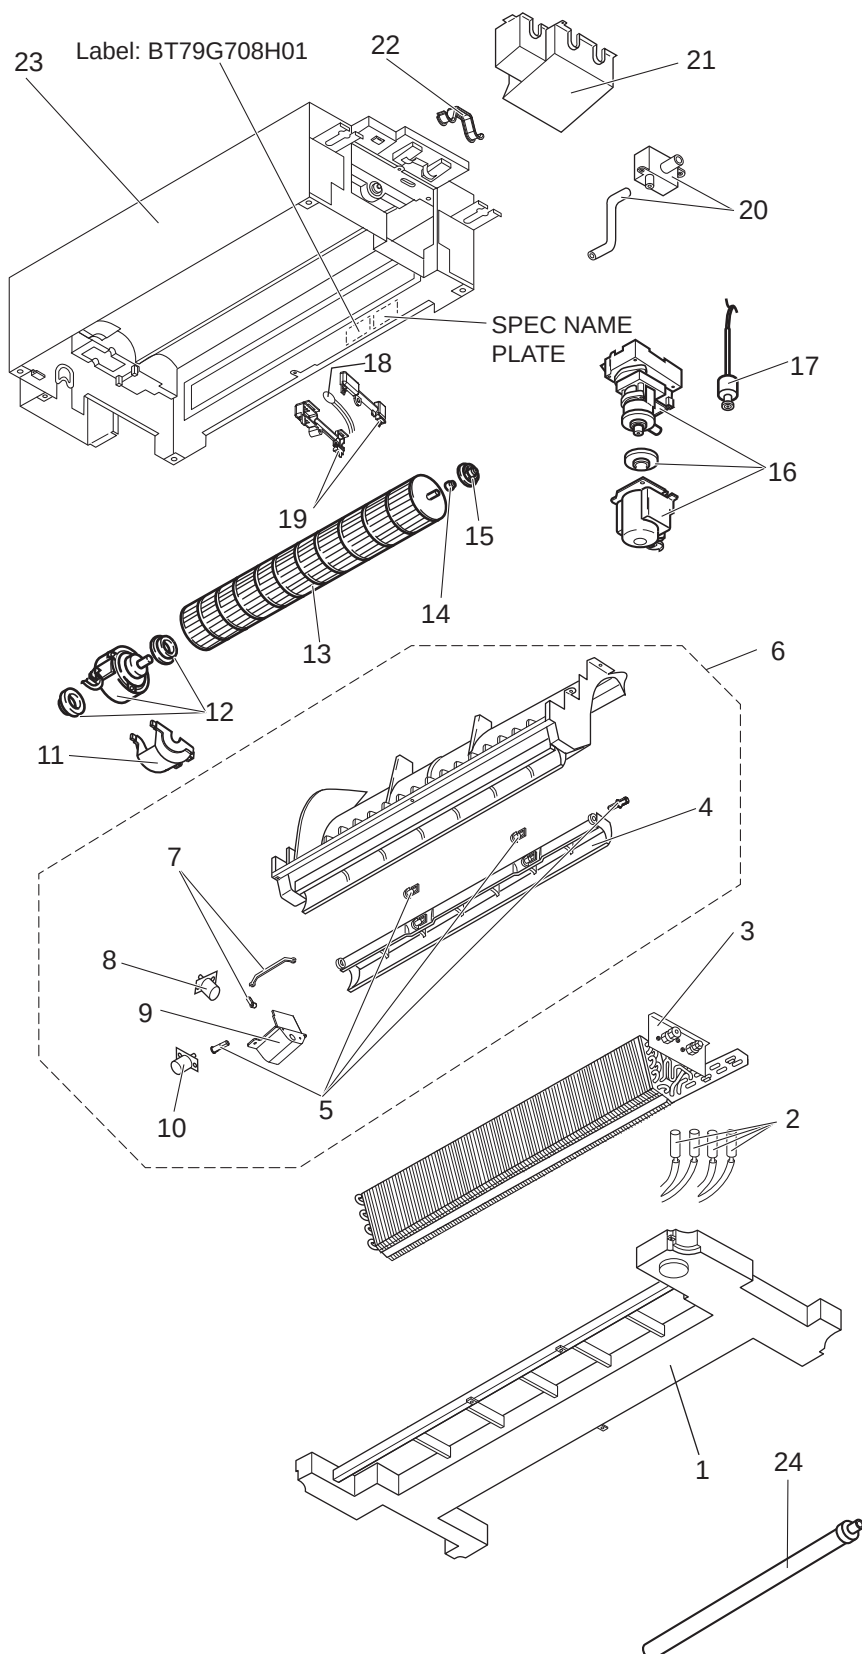
## 1-1. INDOOR UNIT STRUCTURAL PARTS AND FUNCTIONAL PARTS

| No. | Part No. | Part Name | Symbol<br>in Wiring<br>Diagram | Q'ty/unit | | | | | | Remarks |
| 1 | M21 EA4 700 | DRAIN PAN | | 1 | 1 | 1 | 1 | 1 | 1 | |

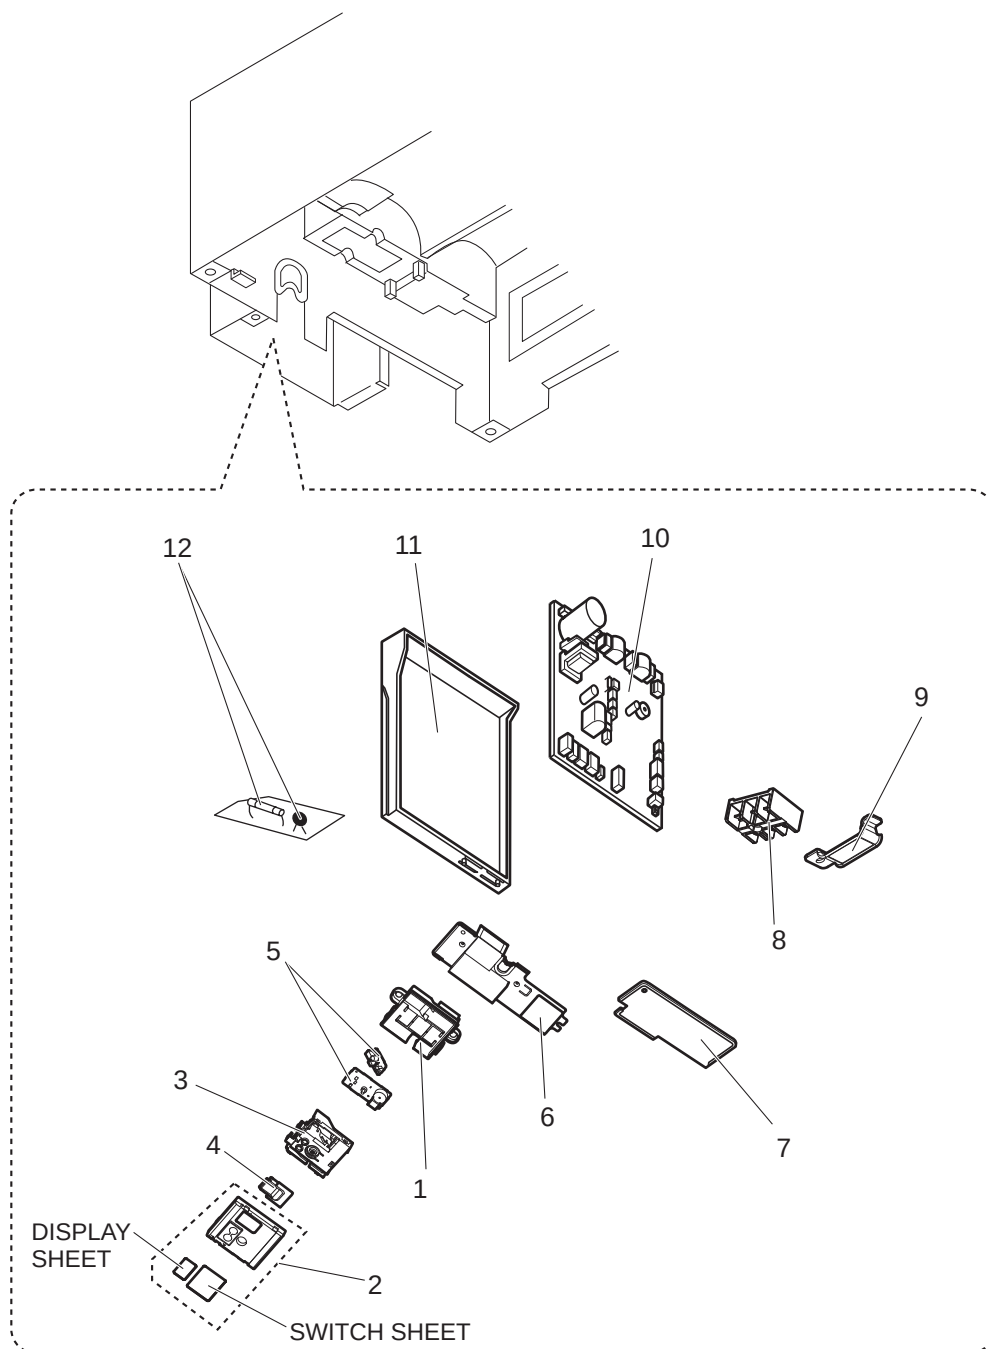
## 1-2. INDOOR UNIT ELECTRICAL PARTS AND FUNCTIONAL PARTS

Part numbers that are circled are not shown in the illustration.

| No. | Part No. | Part Name | Symbol<br>in Wiring<br>Diagram | Q'ty/unit | | | | | | Remarks |
|---|---|---|---|---|---|---|---|---|---|---|
| 5 | T2W EA6 326 | DISPLAY RECEIVER P.C. BOARD ASSEMBLY | | 1 | 1 | 1 | 1 | 1 | 1 | |
| 10 | T2W F76 450 | ELECTRONIC CONTROL P.C. BOARD | | 1 | 1 | | | | | |

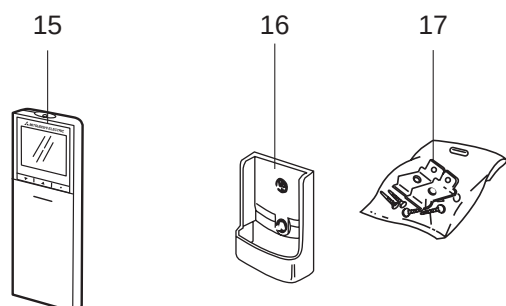
## 1-3. ACCESSORY AND REMOTE CONTROLLER

| No. | Part No. | Part Name | Symbol<br>in Wiring<br>Diagram | Q'ty/unit | | | | | | Remarks |
|---|---|---|---|---|---|---|---|---|---|---|
| 15 | T2W EEY 426 | REMOTE CONTROLLER | | 1 | 1 | 1 | 1 | 1 | 1 | SG175 |
| 16 | T2W EA0 083 | REMOTE CONTROLLER HOLDER | | 1 | 1 | 1 | 1 | 1 | 1 | |

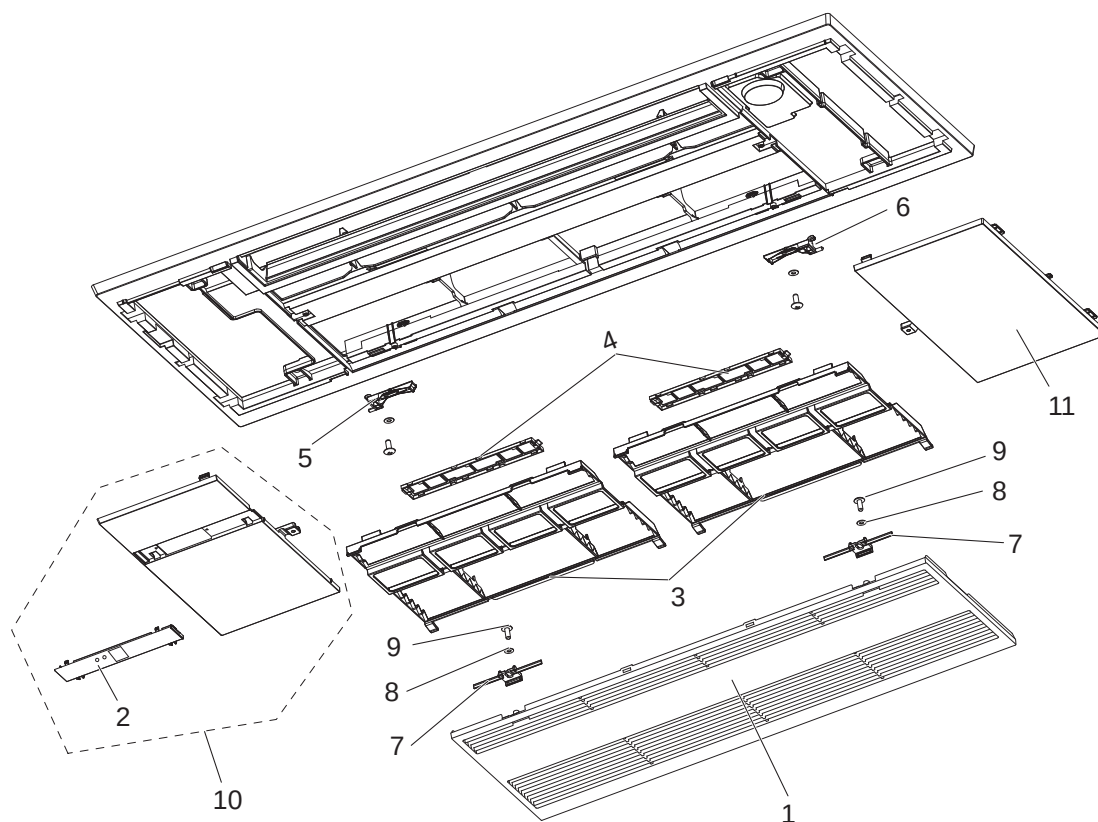
## 2-1. GRILLE

MLP-444W: MLZ-KP·VF-E1, ER1

Part numbers that are circled are not shown in the illustration.

| No. | Part No. | Part Name | Symbol<br>in Wiring<br>Diagram | Q'ty/unit | | | | | | Remarks |
|---|---|---|---|---|---|---|---|---|---|---|
| 1 | M21 ECA 010 | GRILLE ASSEMBLY (W) | | 1 | 1 | 1 | 1 | 1 | 1 | |

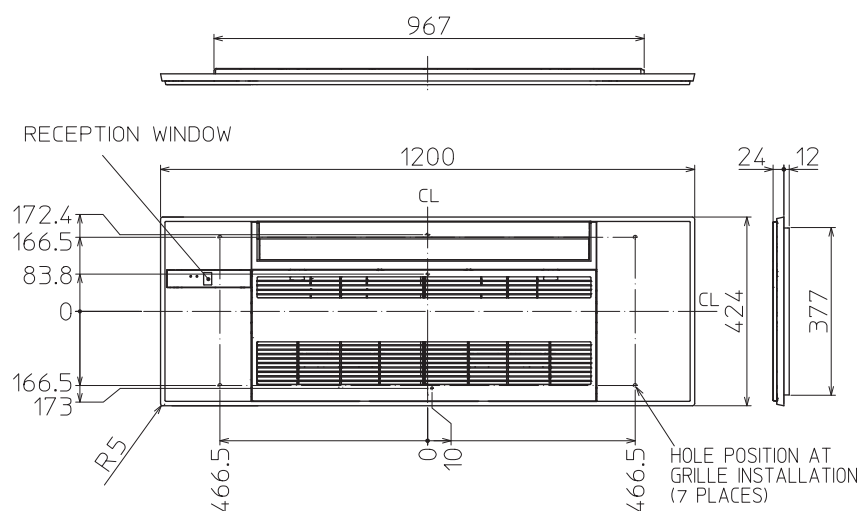
### 2.OUTLINE DRAWING

## GRILLE: MLP-444W

| ITEM | | CONTENTS |
| | MATERIAL | ABS RESIN |

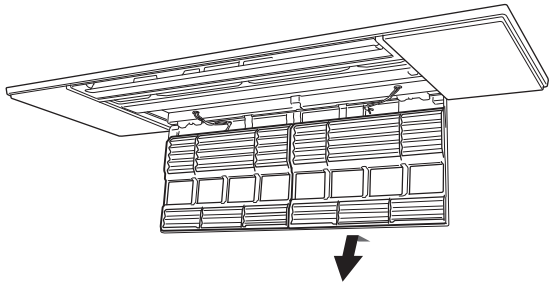
2-2. AIR FILTER (AIR PURIFYING FILTER)

- Clean every 2 weeks
- Remove dirt by a vacuum cleaner, or rinse with water.
- Dry it well in shade before installing it.
- Install the tabs into the intake grille hole.

- Clean the filters regularly for best performance and to reduce power consumption.
- Dirty filters cause condensation in the air conditioner which will contribute to the growth of fungi such as mold.

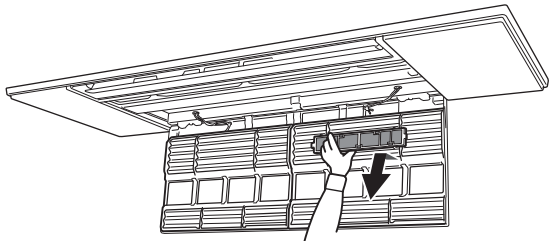
2-3. AIR CLEANING FILTER  
(SILVER-IONIZED AIR PURIFIER FILTER)

Back side of air filter  
Clean every 3 months:

- Remove dirt by a vacuum cleaner.
- Install the tabs into the intake grille hole.

- Soak the filter and its frame in lukewarm water before rinsing it.  
(Diluted mild detergents can be used when dirt cannot be removed.)
- After washing, dry it well in shade.

- Replace it with a new air cleaning filter for best performance.
